AUSTRALIAN NATIONAL UNIVERSITY

DEPARTMENT OF NUCLEAR PHYSICS

14UD TANK OPENING REPORT No.42

4th November to 1st December 1983

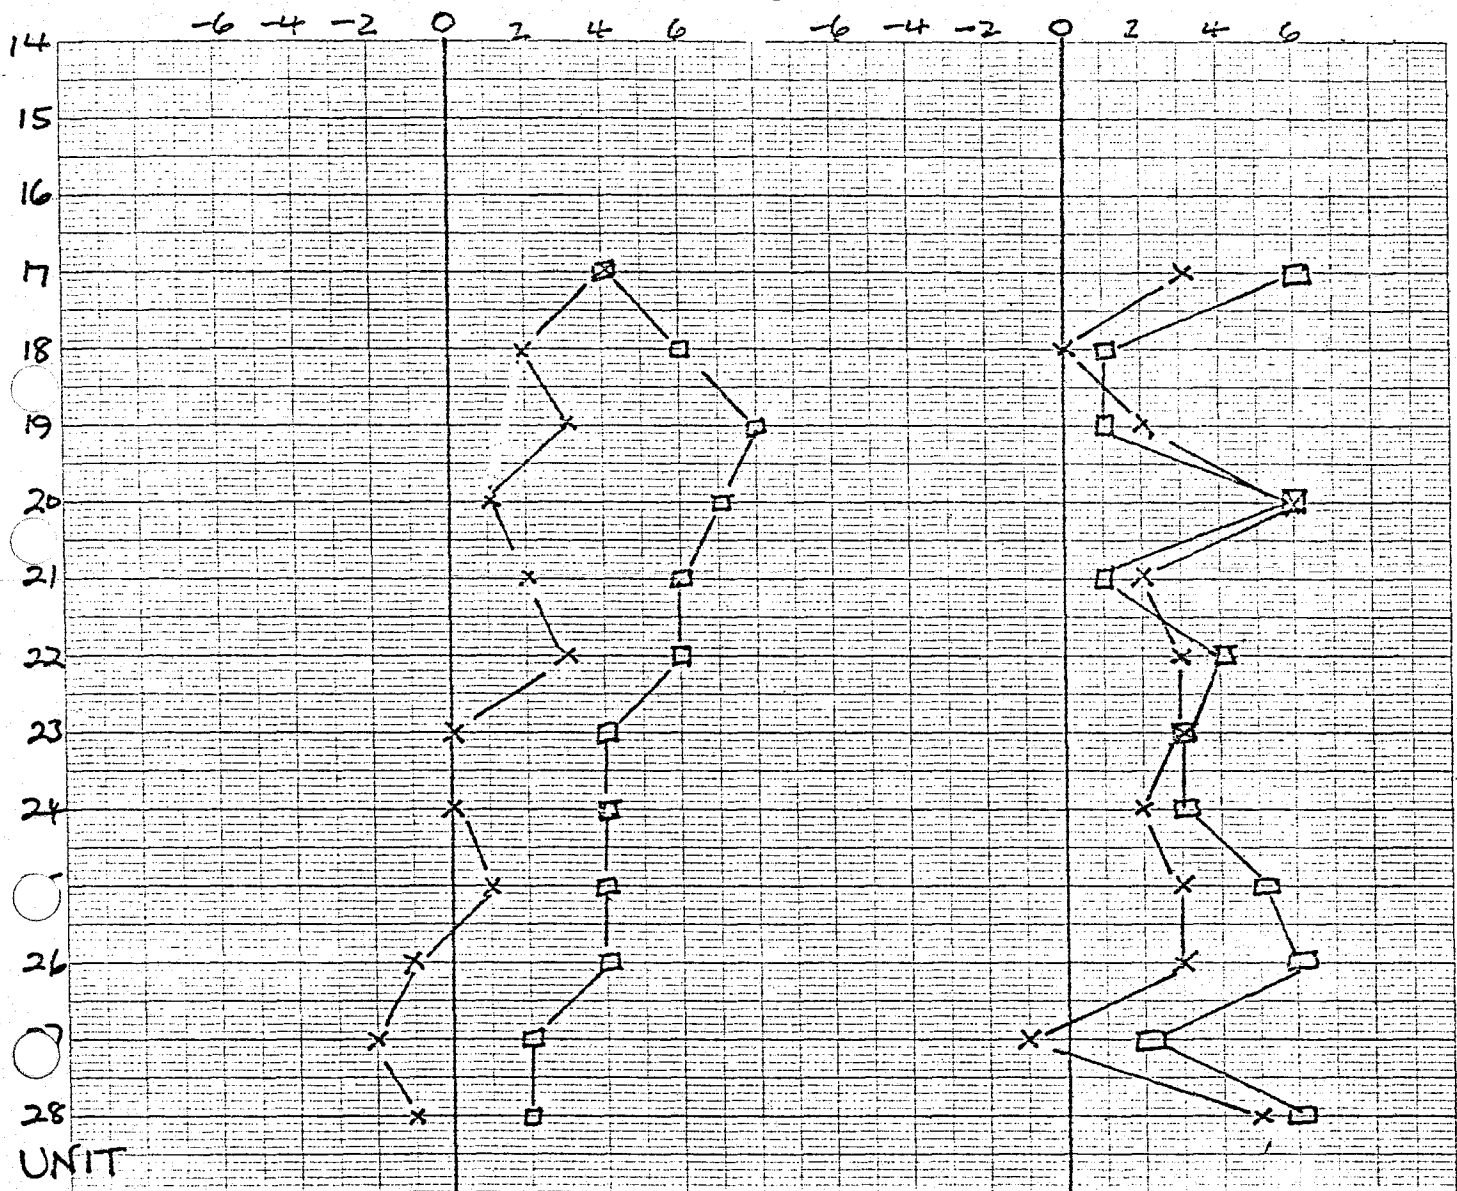
2).

- 2) Plot of centre of chain position in casting holes.
- 3) Xerox of burned foil frames.
- 4) Plot of section of Chain 3.
