**AUSTRALIAN NATIONAL UNIVERSITY**  
**DEPARTMENT OF NUCLEAR PHYSICS**

**14 UD TANK OPENING REPORT # 110**

29th January to 19th February 2009

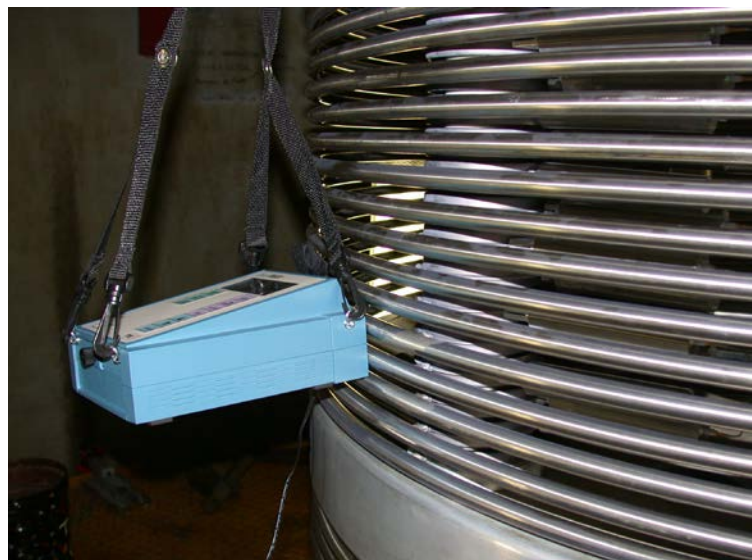
The above picture shows the dust monitor in use during the final blow down. The results will be compared with those taken in various clean rooms and other spaces around the lab. Chart below shows dust concentration inside the machine during various operations. Dust measurements were done every 10 seconds.
