**AUSTRALIAN NATIONAL UNIVERSITY**  
**DEPARTMENT OF NUCLEAR PHYSICS**  
**14 UD TANK OPENING REPORT # 112**  
16<sup>th</sup> November to 19<sup>th</sup> November 2009

**REASON FOR TANK OPENING**

This was an unscheduled opening due to a failure in the accelerator that prevented the machine being able to operate above 14.4 MV.

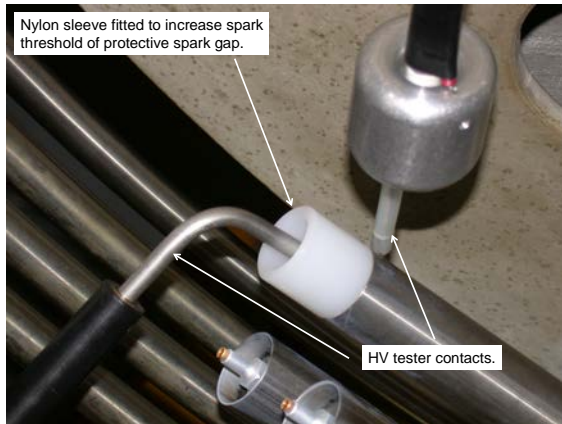
### ALIGNMENT CLAMP AND SPOKE SPARKING IN UNIT#1

Unit 1, Tube 1 - The alignment and support spokes for the tube have a 90° bent leg clamped to the tube flange with a hose clamp.

- The three other column posts in Unit#1 due end cap problems were swapped out.
- The position of the tube alignment spoke clamp and spoke ends on the Tube #1 top flange were adjusted to provide greater clearance to neighbouring tube resistors.
- It was noticed within the resistor assembly of the Unit #2, Tube 1, Gap 4, top resistor that the resistor spark cap was slightly eccentric in its protection tube. The resistor end nut was loosened and spark cap reset using the setting tool.
- The LE end of the machine was wiped clean.
