# 14 UD Tank Opening Report

## 117A/B

5<sup>th</sup> July to 17<sup>th</sup> – August 2012 (A)  
20<sup>th</sup> to 24<sup>th</sup> – August 2012 (B)

Department of Nuclear Physics  
Research School of Physics and Engineering  
Building #57, The Australian National University  
Canberra ACT 0200

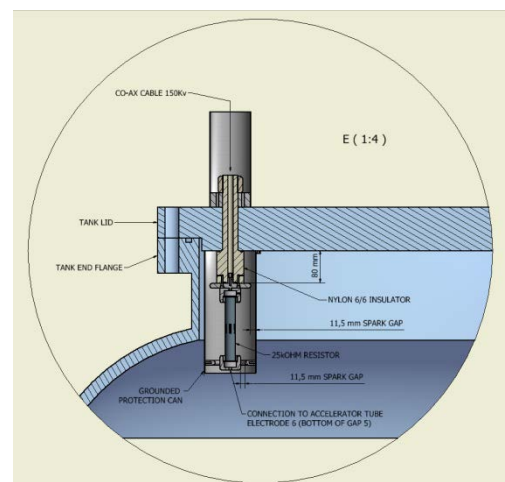
A new system of controlling the beam focusing lens at the entrance of the accelerator is being developed. This involves the provision of +150kV onto the 6th tube electrode (5 gaps) of the first tube in unit 1.

This provides a similar voltage gradient across the first 5 gaps as is achieved when operating the accelerator at maximum operational terminal voltage, equivalent to ~1MV per unit. It will provide a tunable lens in the first acceleration tube at the entrance of the machine.

Using the 150kV supply will reduce the need for the laborious changes of shorting rods to match the researchers' required terminal potentials, as well as provide the ability to tune a crucial optical element of the accelerator. The shorting rod systems will be retained for the very important conditioning and diagnostics operations. It may also prove necessary for operation at very low terminal voltages.

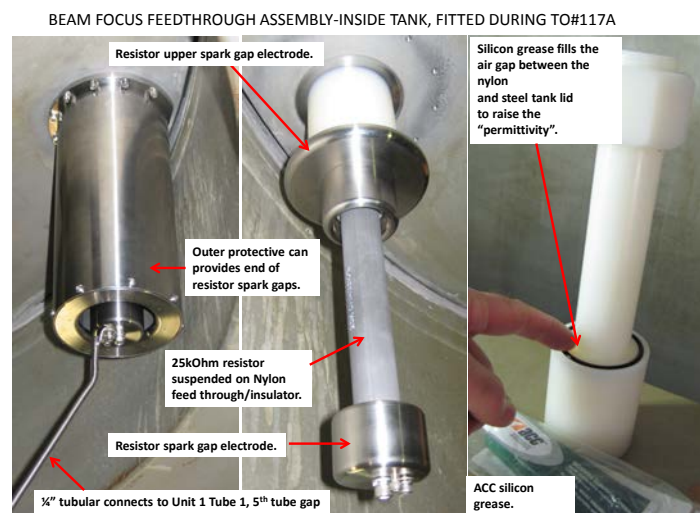
The nylon insulation distance was deemed inadequate and was increased to 80mm from the Version I, where it was only 25mm long.

The V II feedthrough hardware had been manufactured in the main workshop and was now ready for installation.
