Australian  
National  
University

# 14 UD Tank Opening Report

## #121

6 January – 26 February 2014

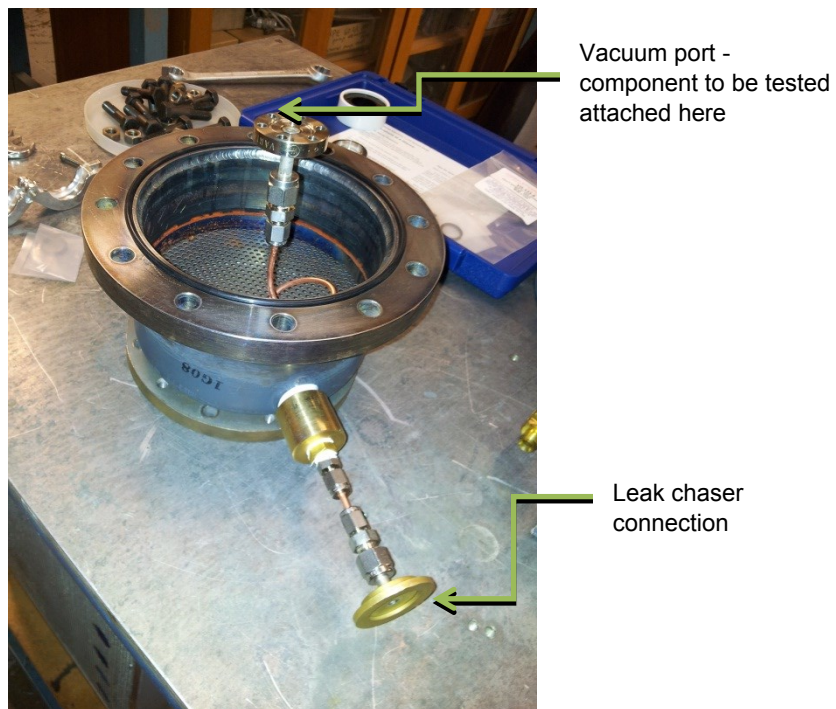
*Figure 1 Bottom component of pressure chamber used for pressurised leak testing*

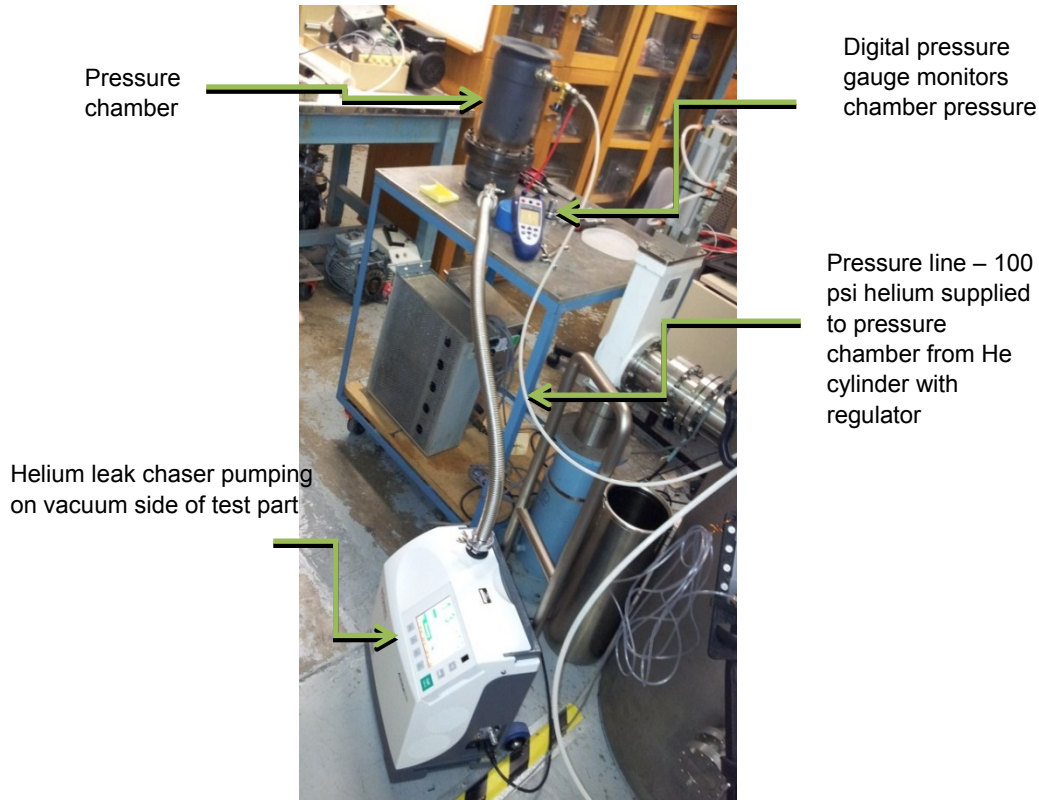
*Figure 2 Complete pressurised leak testing setup*

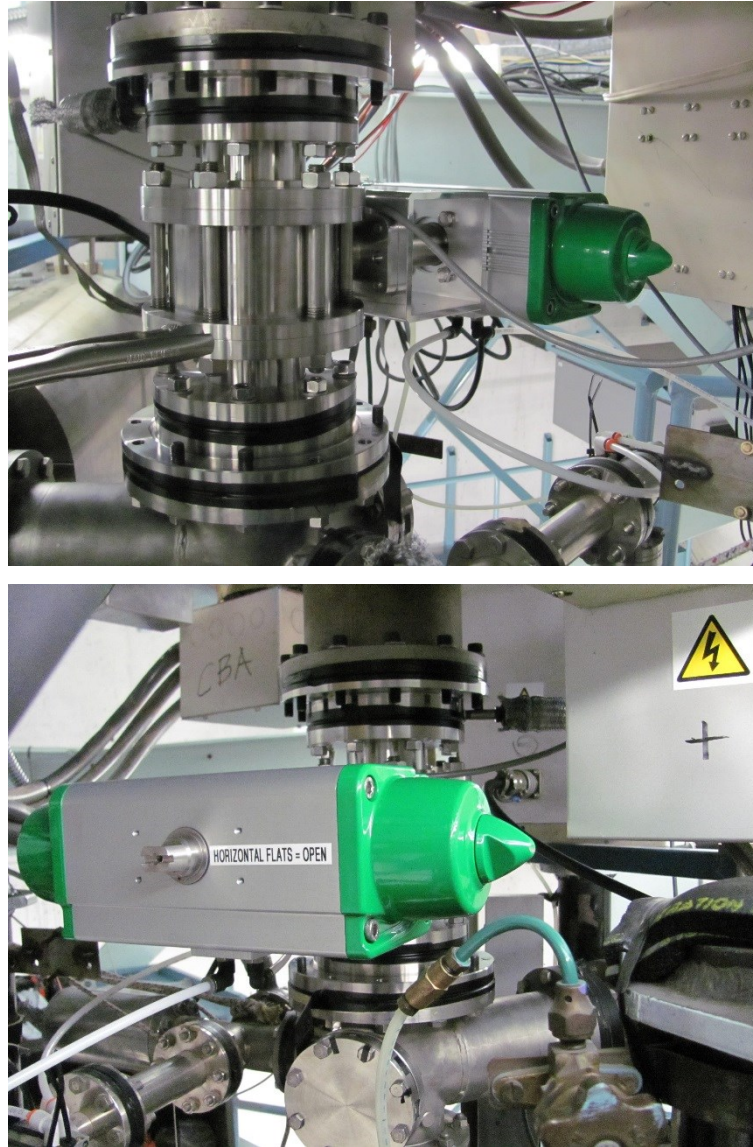
Since the acceleration tube was vented, an opportunity presented itself to install a new ball valve at the high-energy end of the tube. The valve itself is much the same as the ball valve at the low-energy end of the tube (see TOR #117 for details)

*Figure 3 New high-energy ball valve installation below 14UD tank*

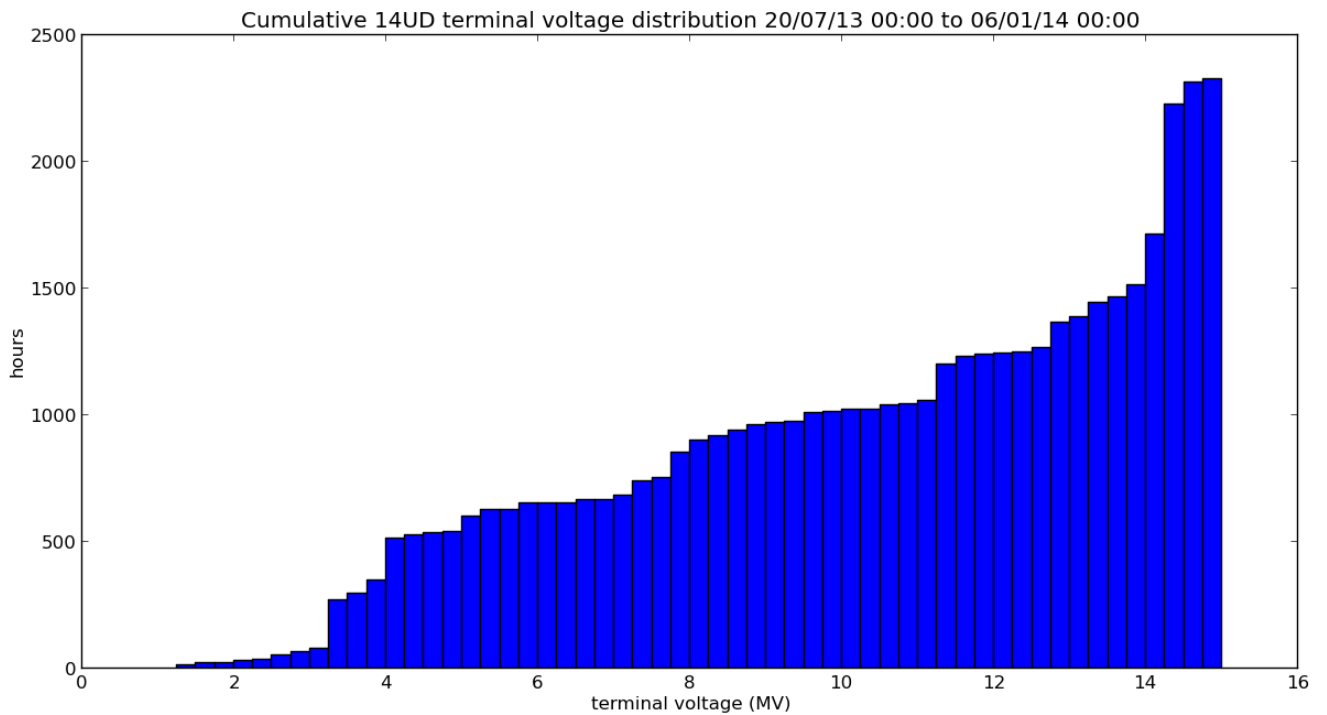
Figure 12 Cumulative terminal voltage distribution for period of operation from the end of tank opening 120 to the start of tank opening 121
