14 UD Tank Opening Report

#123

8th July – 31st July 2014

Department of Nuclear Physics
Research School of Physics and Engineering
Building #57, The Australian National University
Canberra ACT 0200

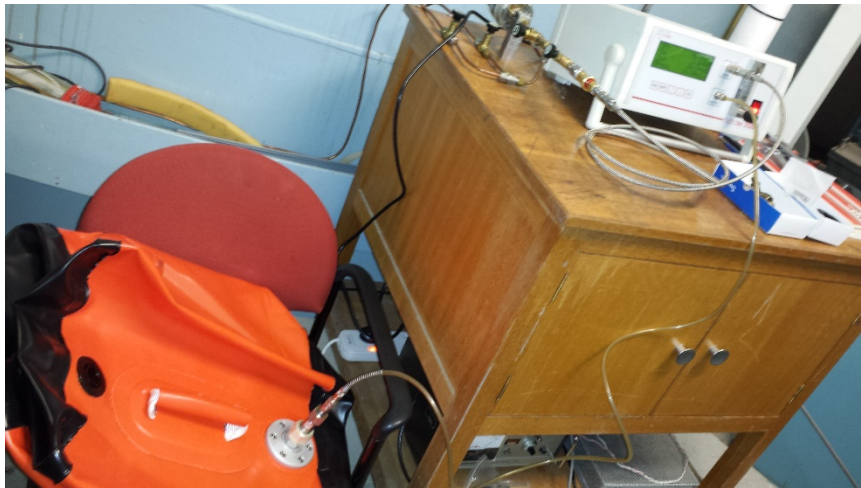
Measurements were taken at level 4 by flowing SF₆ from the 14UD tank at 2 l/min through the analyzer until the reading stabilized. All SF₆ was captured by the gas bag as shown in Figure 5. Results pre- and post-tank opening are shown in Figure 6 and Figure 7 respectively.

Figure 5 Gas testing set up.
