14 UD Tank Opening Report

#124

14th May – 12th June 2015

Department of Nuclear Physics
Research School of Physics and Engineering
Building #57, The Australian National University
Canberra ACT 0200

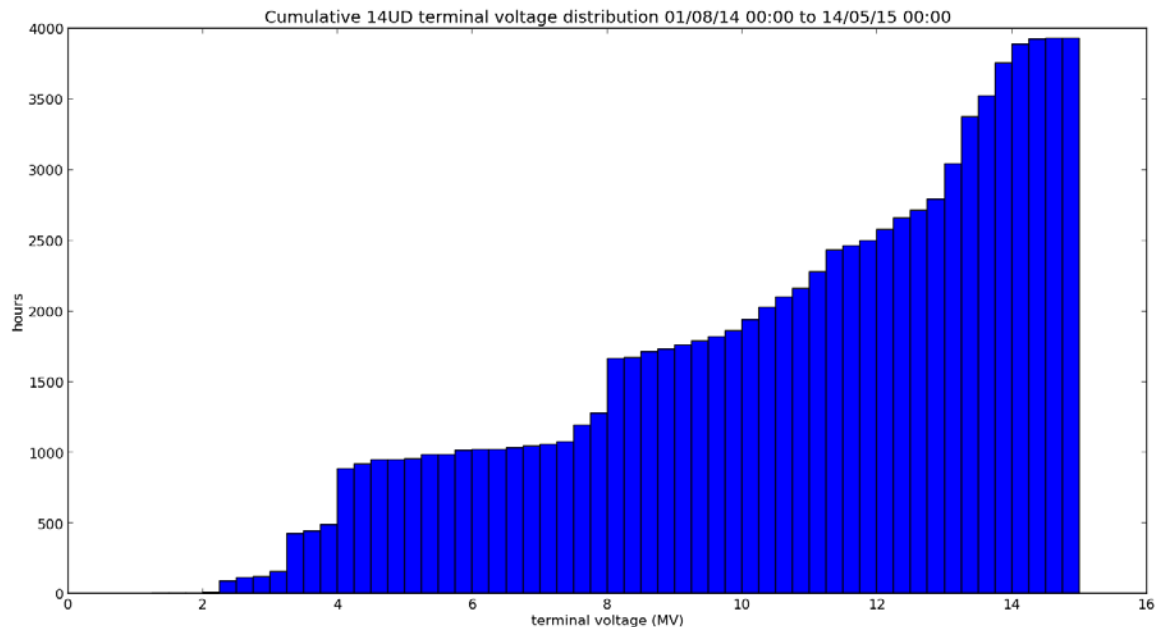
Figure 10 Cumulative terminal voltage distribution for period of operation from the end of tank opening 123 to the start of tank opening 124

Total hours with voltage on terminal was 3926 hrs, which gives a utilization of 60% assuming a twenty-four hour, seven-day maximum.

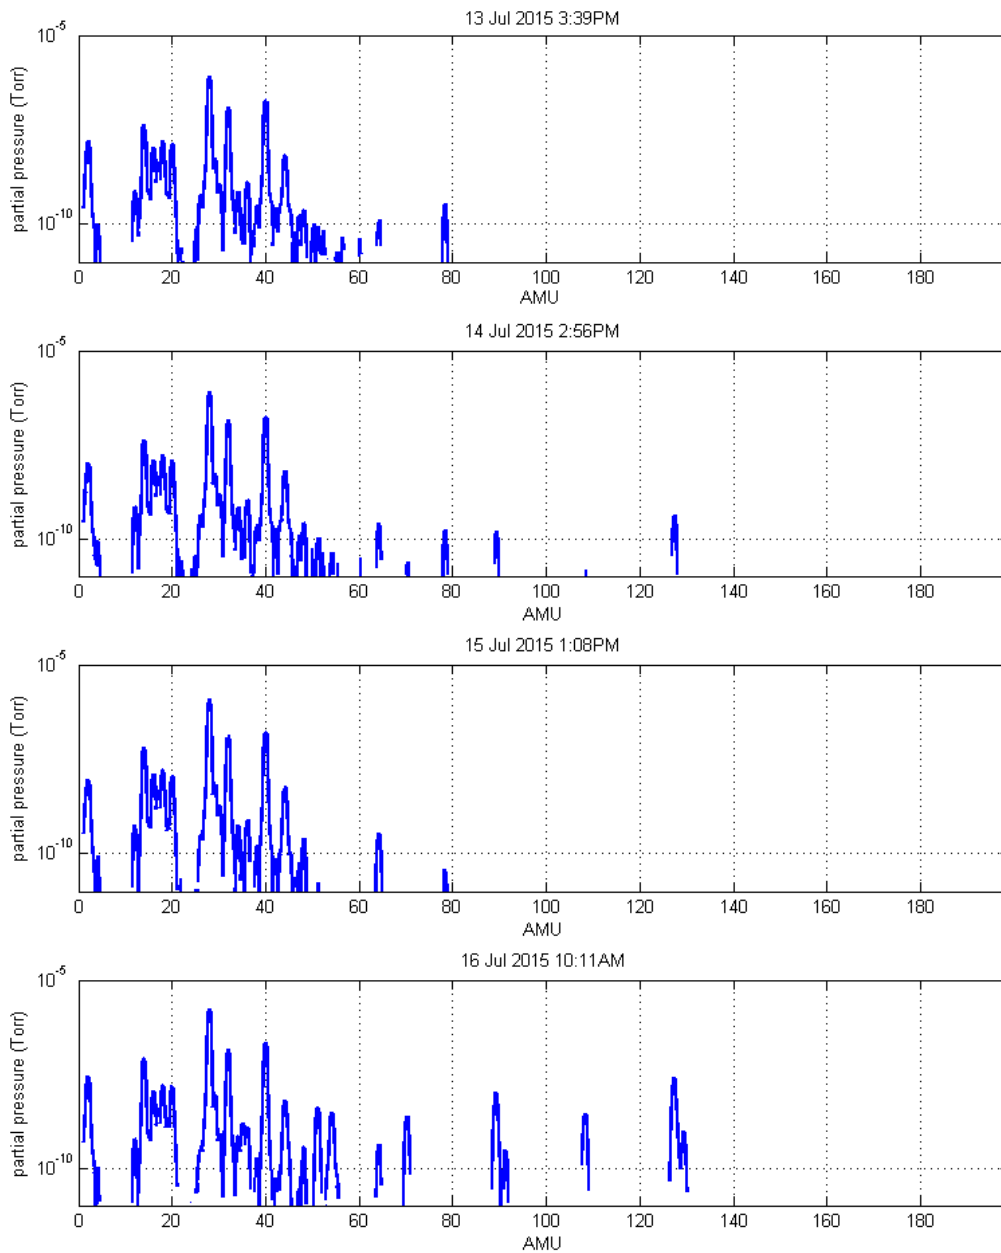
Figure 13 RGA scans taken after TO 124. A round of conditioning was performed between the 15th and 16th of July. In all traces, the shafts were off (no pumping in the terminal) overnight and the 300l/s ion pump at the low-energy end was switched off for at least two hours to allow any gasses in the terminal to reach the position of the RGA at the low-energy end.
