Australian
National
University

14 UD Tank Opening Report

#125

15th February – 17th March 2016

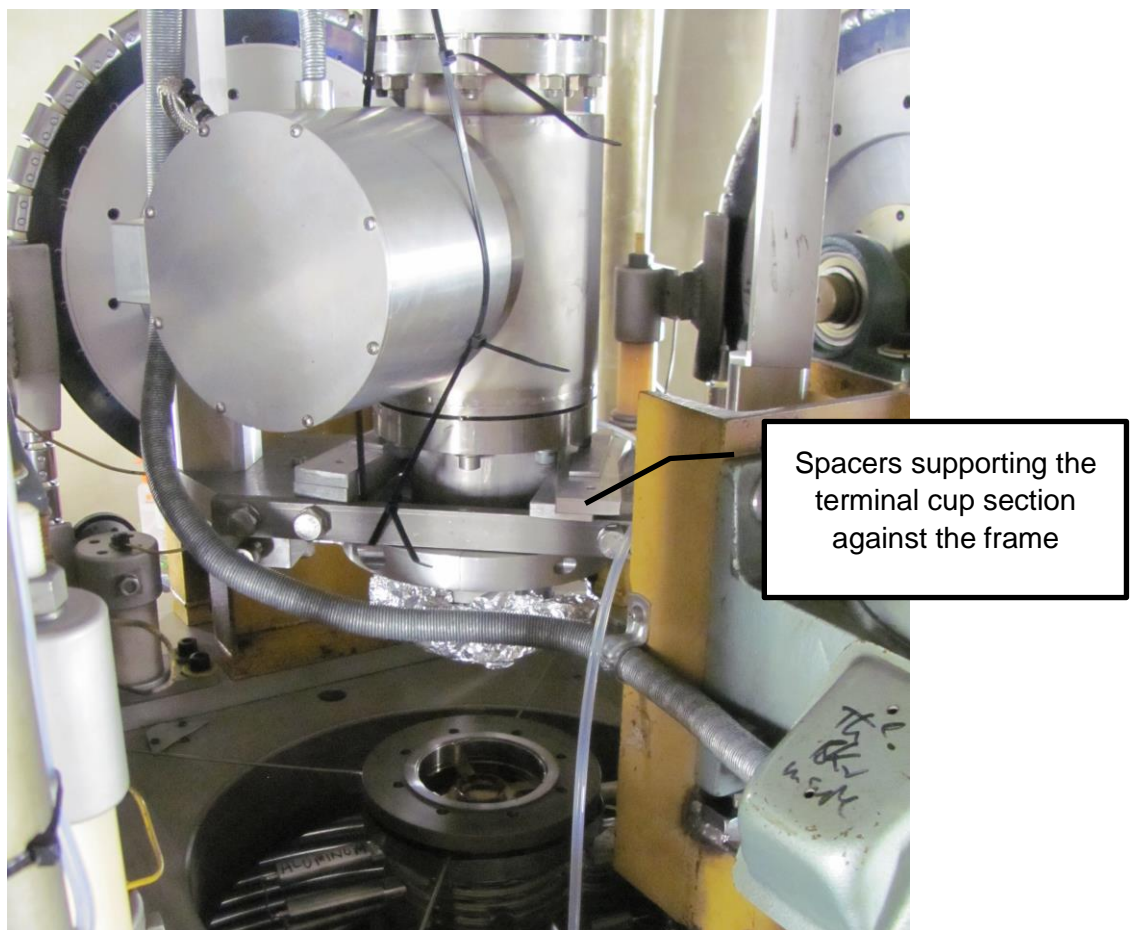
Figure 4-1 Terminal, bellows removed

It was discovered that within the bellows was an aperture stack that was sitting loose inside. After careful consideration it was decided to slide a piece of sheet metal underneath the bellows to capture the aperture stack inside and slide them out together.

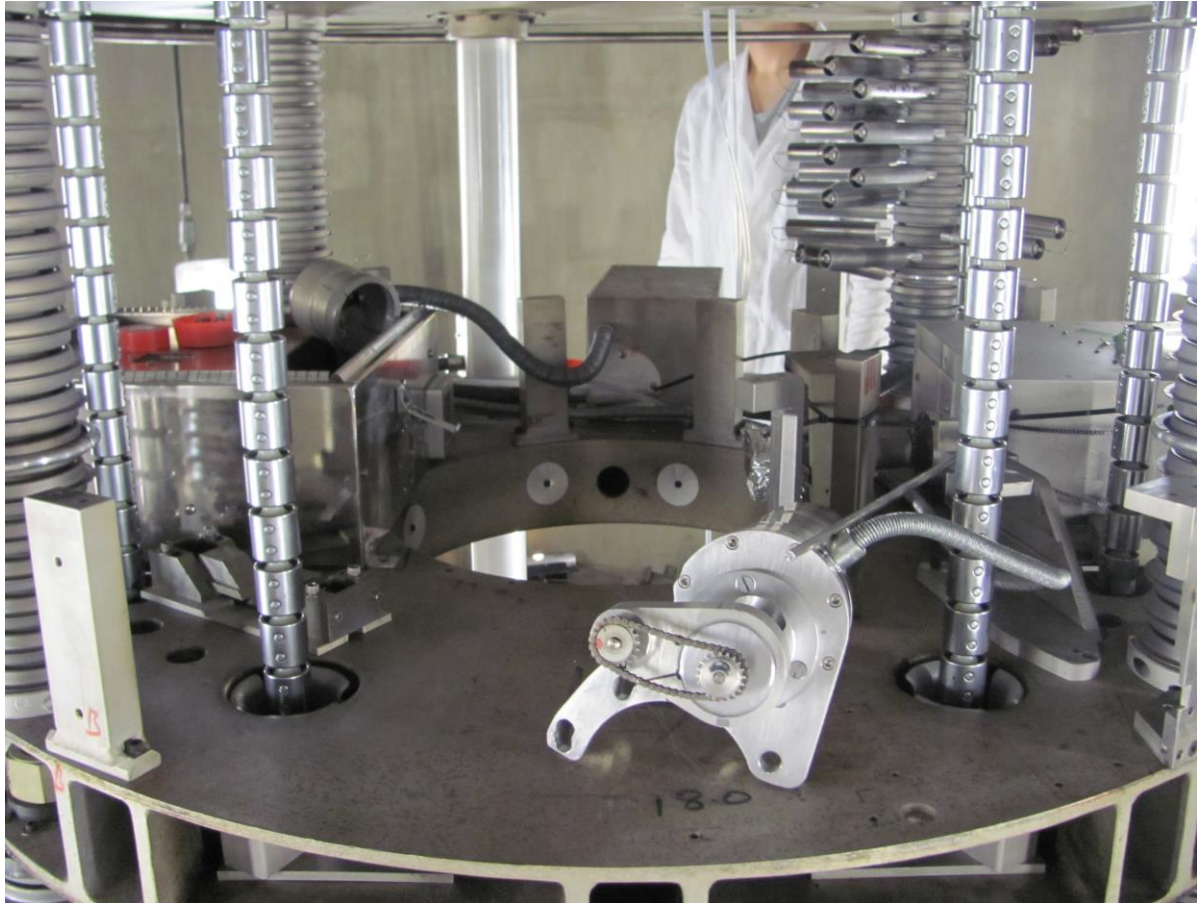
Figure 4-2 U19 Stripped

In order to remove the stripper, much of U19 had to be disassembled. This involved removing casting covers, rings, deck, pedestals, stripper motor, and loosening the electronics boxes. The foil stripper was removed for repopulation, and the conflat connection to the Ion pump was disconnected.

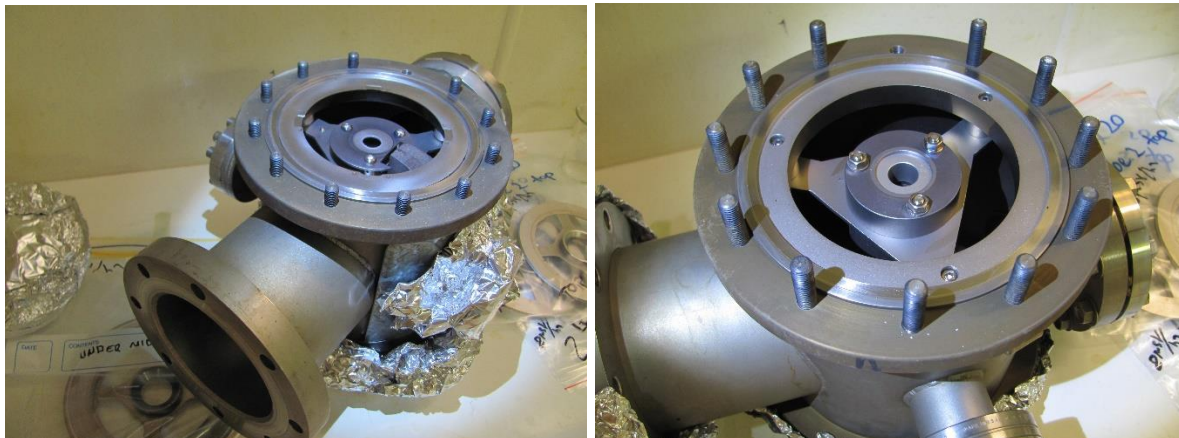
Figure 4-4 HE stripper assembly Top (left) and Bottom (right)

It was noted that the top suppressor aperture of the HE stripper had a sputtered area of about 25mm around its 12.5mm hole and this may be the source of a lot of backstreamed electrons. It was also noted that the set of 3 suppressor apertures are all biased to the same voltage. The suppressor arrangement was perplexing and further investigation will need to be done to understand how it works (or doesn't) and if it can be improved.

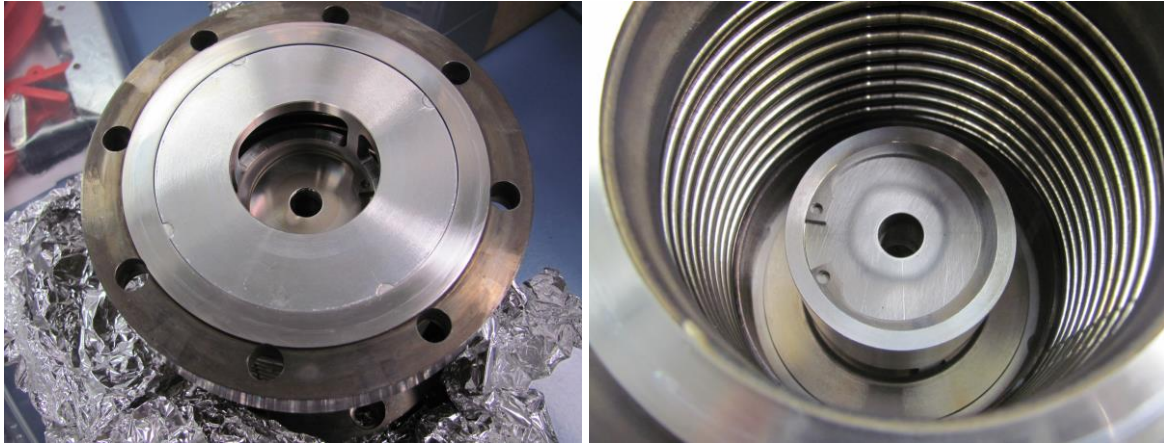
Figure 4-11 Bellows Aperture Stack Installed

When the bellows was removed, the aperture stack was loose, however four tags on the base of the aperture stack seemed to indicate that it fit snugly in the bore of the bottom flange of the bellows. Heating the bellows flange (130°C) created enough expansion for the stack to drop into the recess and securely hold it when cooled.

A wire gasket was fitted to the bottom of the bellows and it was put in place and the bottom flange tightened. Getting a gasket on the top was tricky, so it was decided to make a precision gasket to put in place with no foil/tape and lower the above assembly onto it, pinching it in place. The standard gasket for the bellows flange is 112mm diameter, however, the mating flange had a smaller ID, so to ensure the gasket was pinched between the two flanges a custom 118mm gasket was made. The gasket was stretched over a buck and flattened so it could be installed without the need to foil/tape it down.

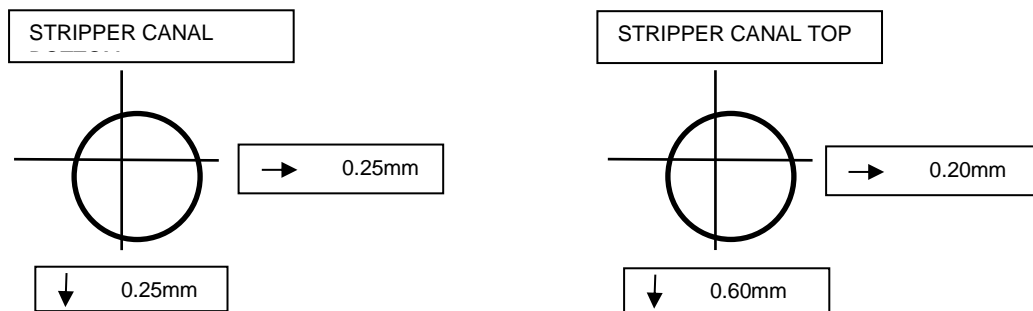
Before work commenced inside the tank, the alignment was approximately thus:

This represented the orientation of the crosshairs as viewed by the operator on Level 4.5. In the above the left approximately corresponds with the position of Post C, the right Post A, up with Post D and down with Post B.

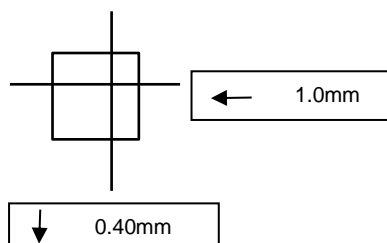
With slits at 0.040" open the following alignment was observed:

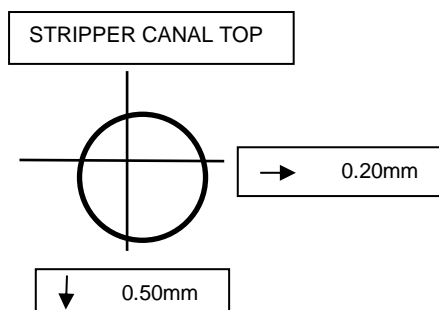
Once the terminal was opened the top of the Stripper Canal measurement was repeated by Peter L, his measurements broadly similar to those taken earlier;

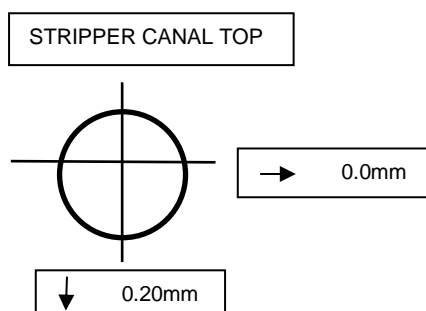
Further adjustments to posts (mainly immediately below the terminal) arrived at an alignment at the top of the stripper canal of:

So overall we feel we improved the alignment at the Stripper Canal by approximately 0.5mm.

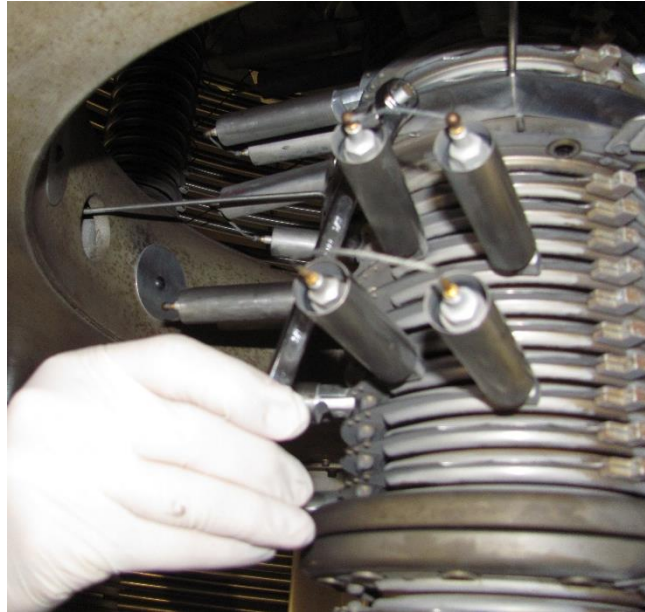
Figure 4-14 Loosening Spoke Clamp to Allow Rotation

The mid-section was installed, and subsequently the other two tubes. Rotational alignment problems were encountered on the last joint due to progressive errors in the tubes. The spoke clamps of the upper section of the tubes was released and the tube stack was able to be rotated until all holes lined up.

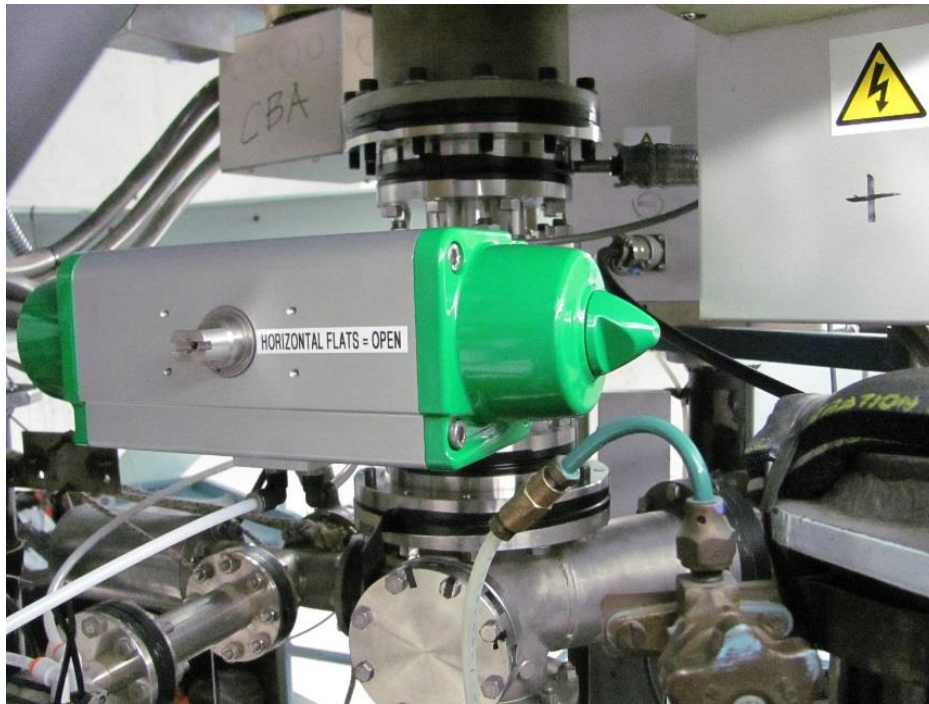
Figure 8-1 HE Ball Valve in situ

This new HE ball valve was installed during TO121 in February 2014. Since its installation, we have had a consistent problem with leaking through when in the closed position. It was decided to remove the valve during this tank opening and install new Teflon seals to the ball.

On inspection there were scratches on the ball and there was also a defect – like impact damage/weld spatter? – which would be damaging the Teflon seals when opening/closing. A new ball was ordered from A&N.

Valve was reinstalled and has since been found to be working as it should, with no leaking through when closed.

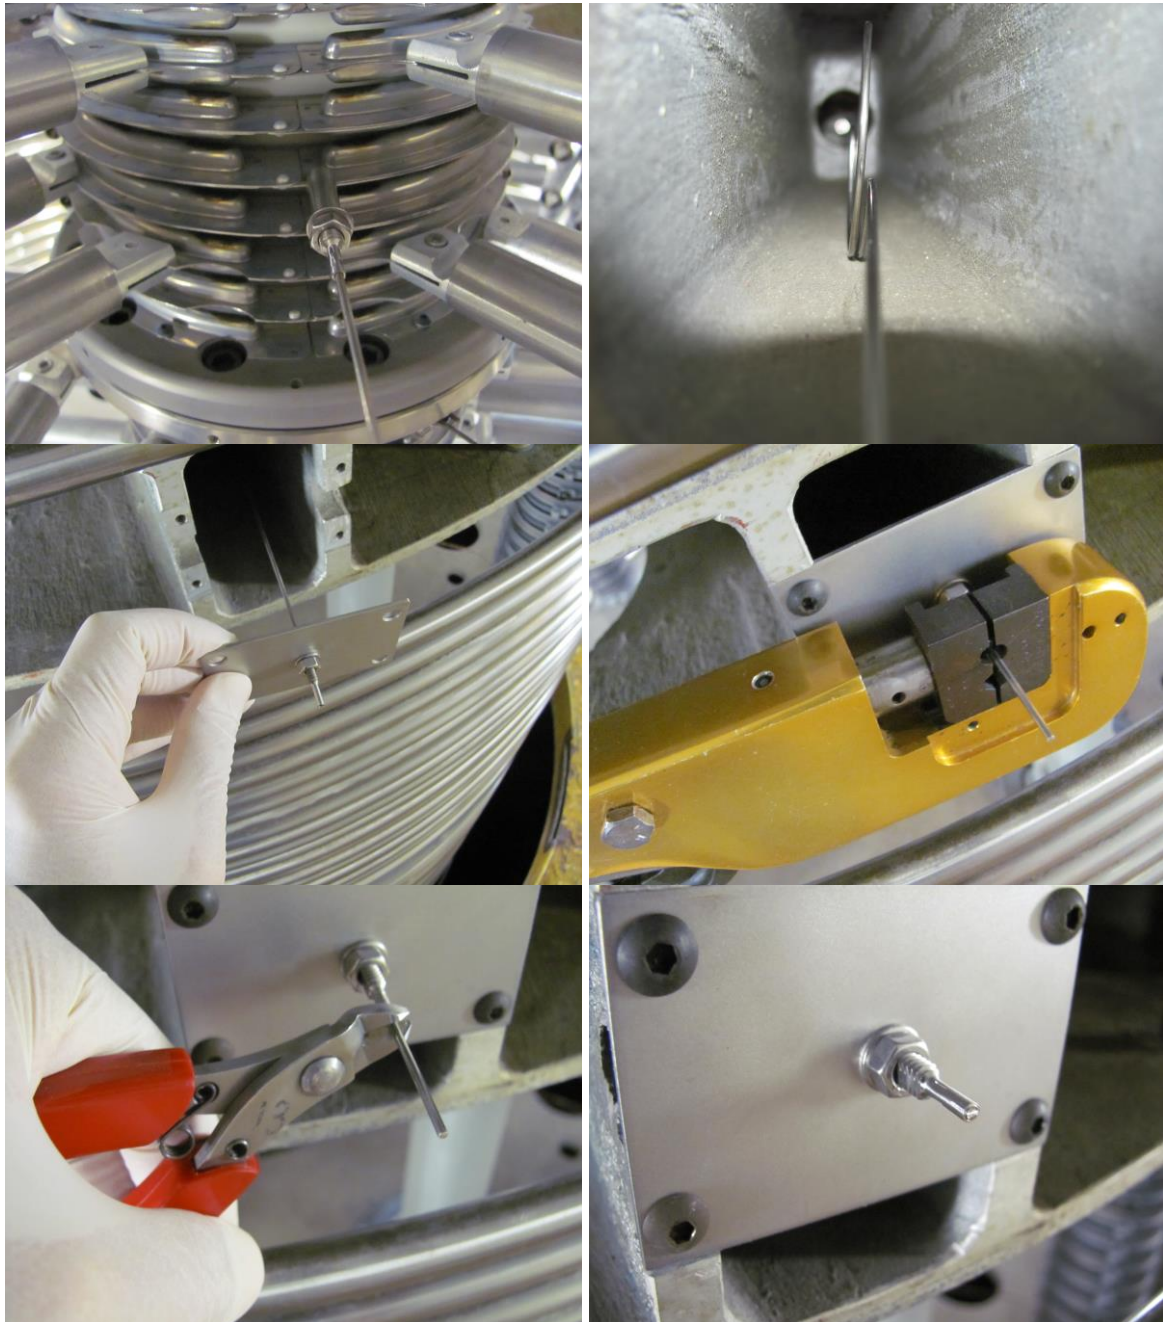
Figure 10-1 Single Unit Conversion installation.

The single unit conversion project is designed to electrically connect the middle electrode of the 8 gap tubes to the casting to eliminate any voltage disparity. It was decided to trial the idea on one unit with the idea to implement it throughout the machine if it proves to be good. Unit 1 was chosen to install the conversion on.

The system involves connecting an NEC style clamp to the electrode. The clamp is crimped onto a wire with a loop (so as not to influence alignment) which is then crimped to a plate feedthrough bolted to the casting and trimmed. Note that the plate connection is done in place to eliminate problems with varying distances.
