Australian
National
University

14 UD Tank Opening Report

#126

19th May – 13th June 2016

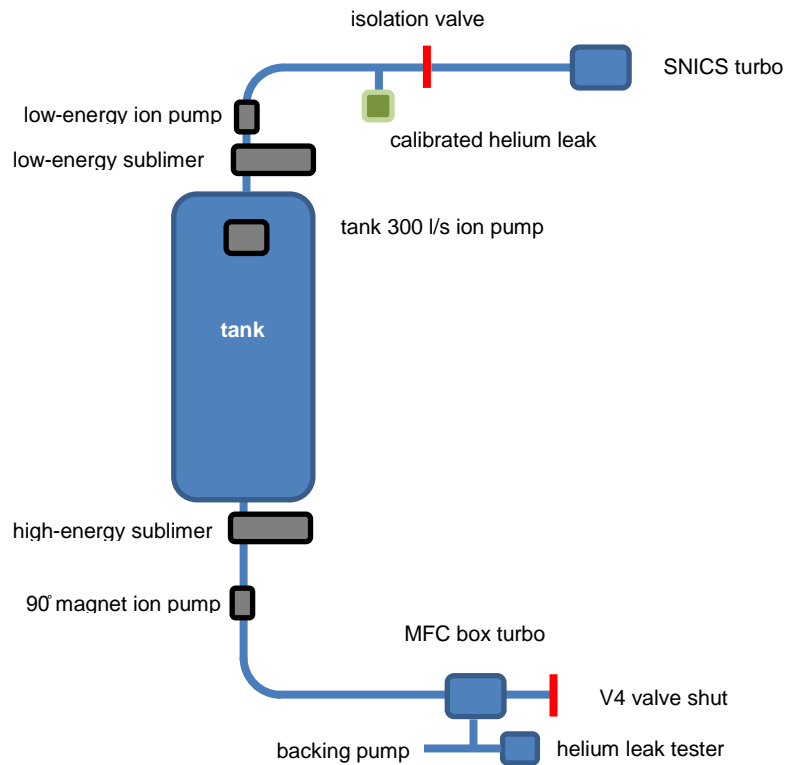
Figure 5 Configuration used for helium leak test sensitivity tests

Leak testing should be performed with pumps off for maximum sensitivity, although the tube vacuum should be observed, as it did deteriorate to low 10^{-6} Torr during the test.

Also note the background base leak rate, which was in the vicinity of 1.4×10^{-9} mbar·l/s.

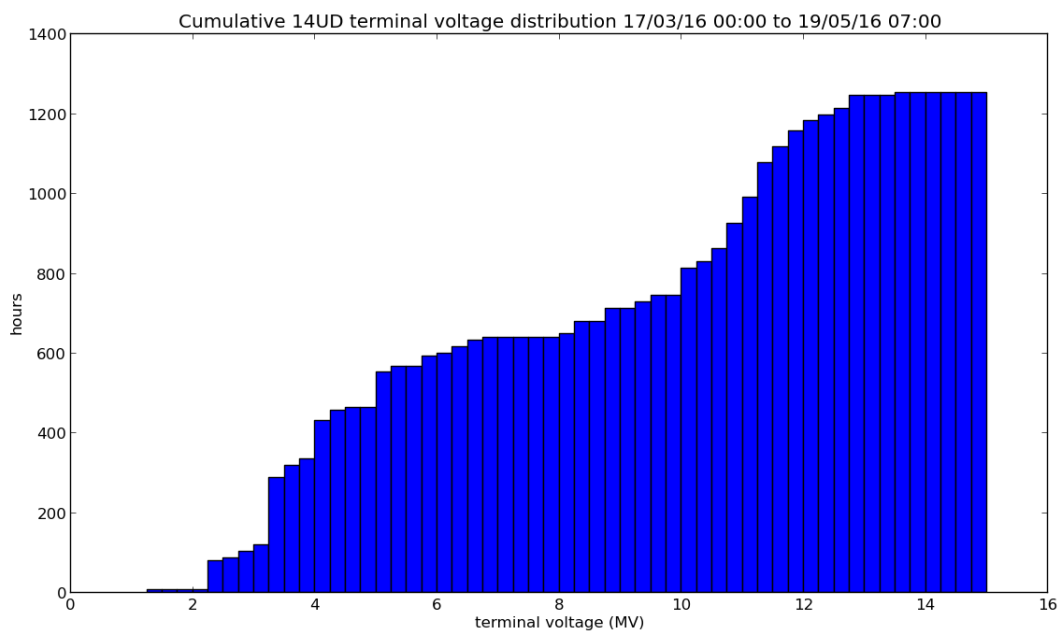
Figure 9 Cumulative terminal voltage distribution for period of operation from the end of tank opening 125 to the start of tank opening 126

The total hours with voltage on the terminal was 1254 hrs, which gives a utilization of 83% assuming a twenty-four hour, seven-day maximum.
