Australian  
National  
University

# 14 UD Tank Opening Report

## #128

16<sup>th</sup> October – 10<sup>th</sup> November 2017

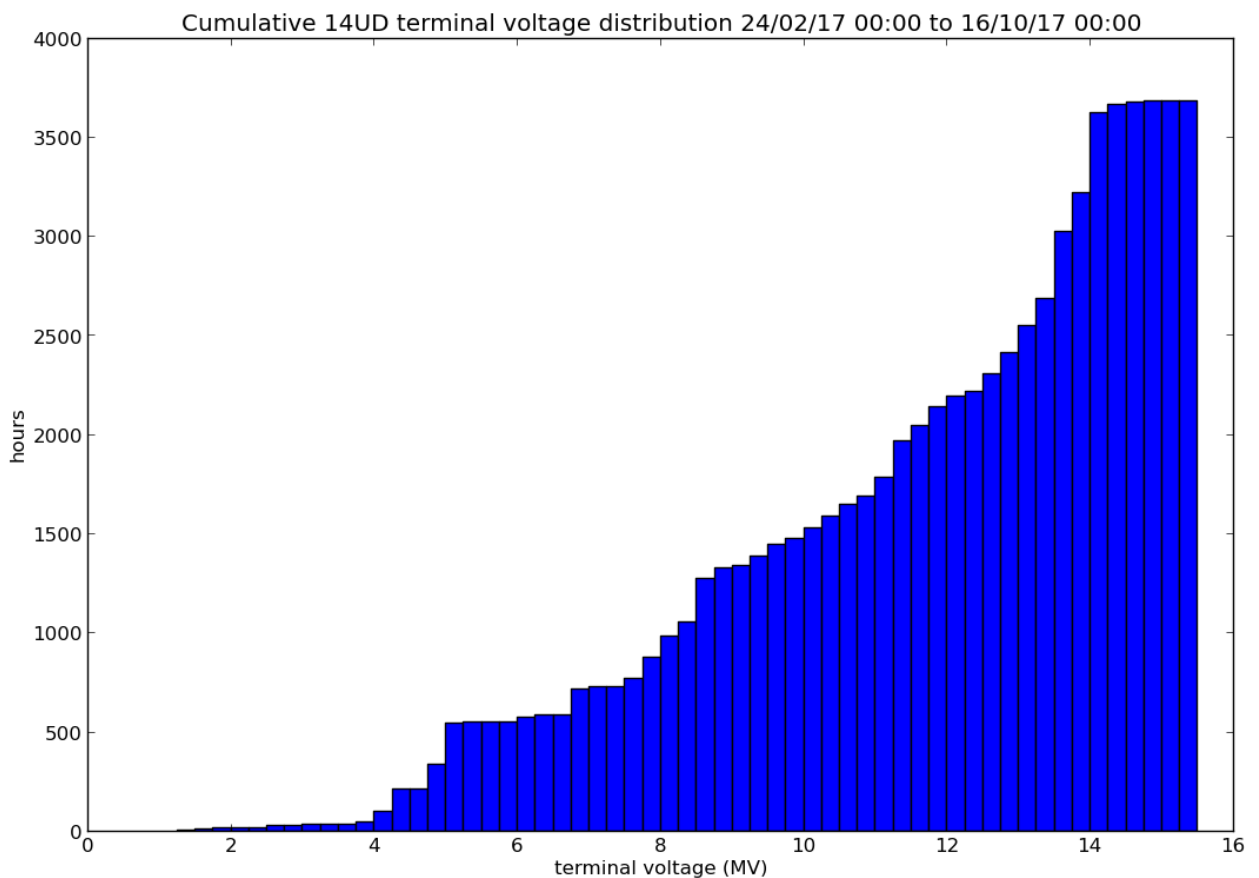
Figure 4 Cumulative terminal voltage distribution for period of operation from the end of tank opening 127 to the start of tank opening 128 (including any time spent conditioning the machine)

The total hours with voltage on the terminal was 3685 hrs, which gives a utilization of 66% assuming a twenty-four hour, seven-day maximum.
