AUSTRALIAN NATIONAL UNIVERSITY

DEPARTMENT OF NUCLEAR PHYSICS

14UD TANK OPENING REPORT No.39

5th to 7th April 1983. (3 days open.)

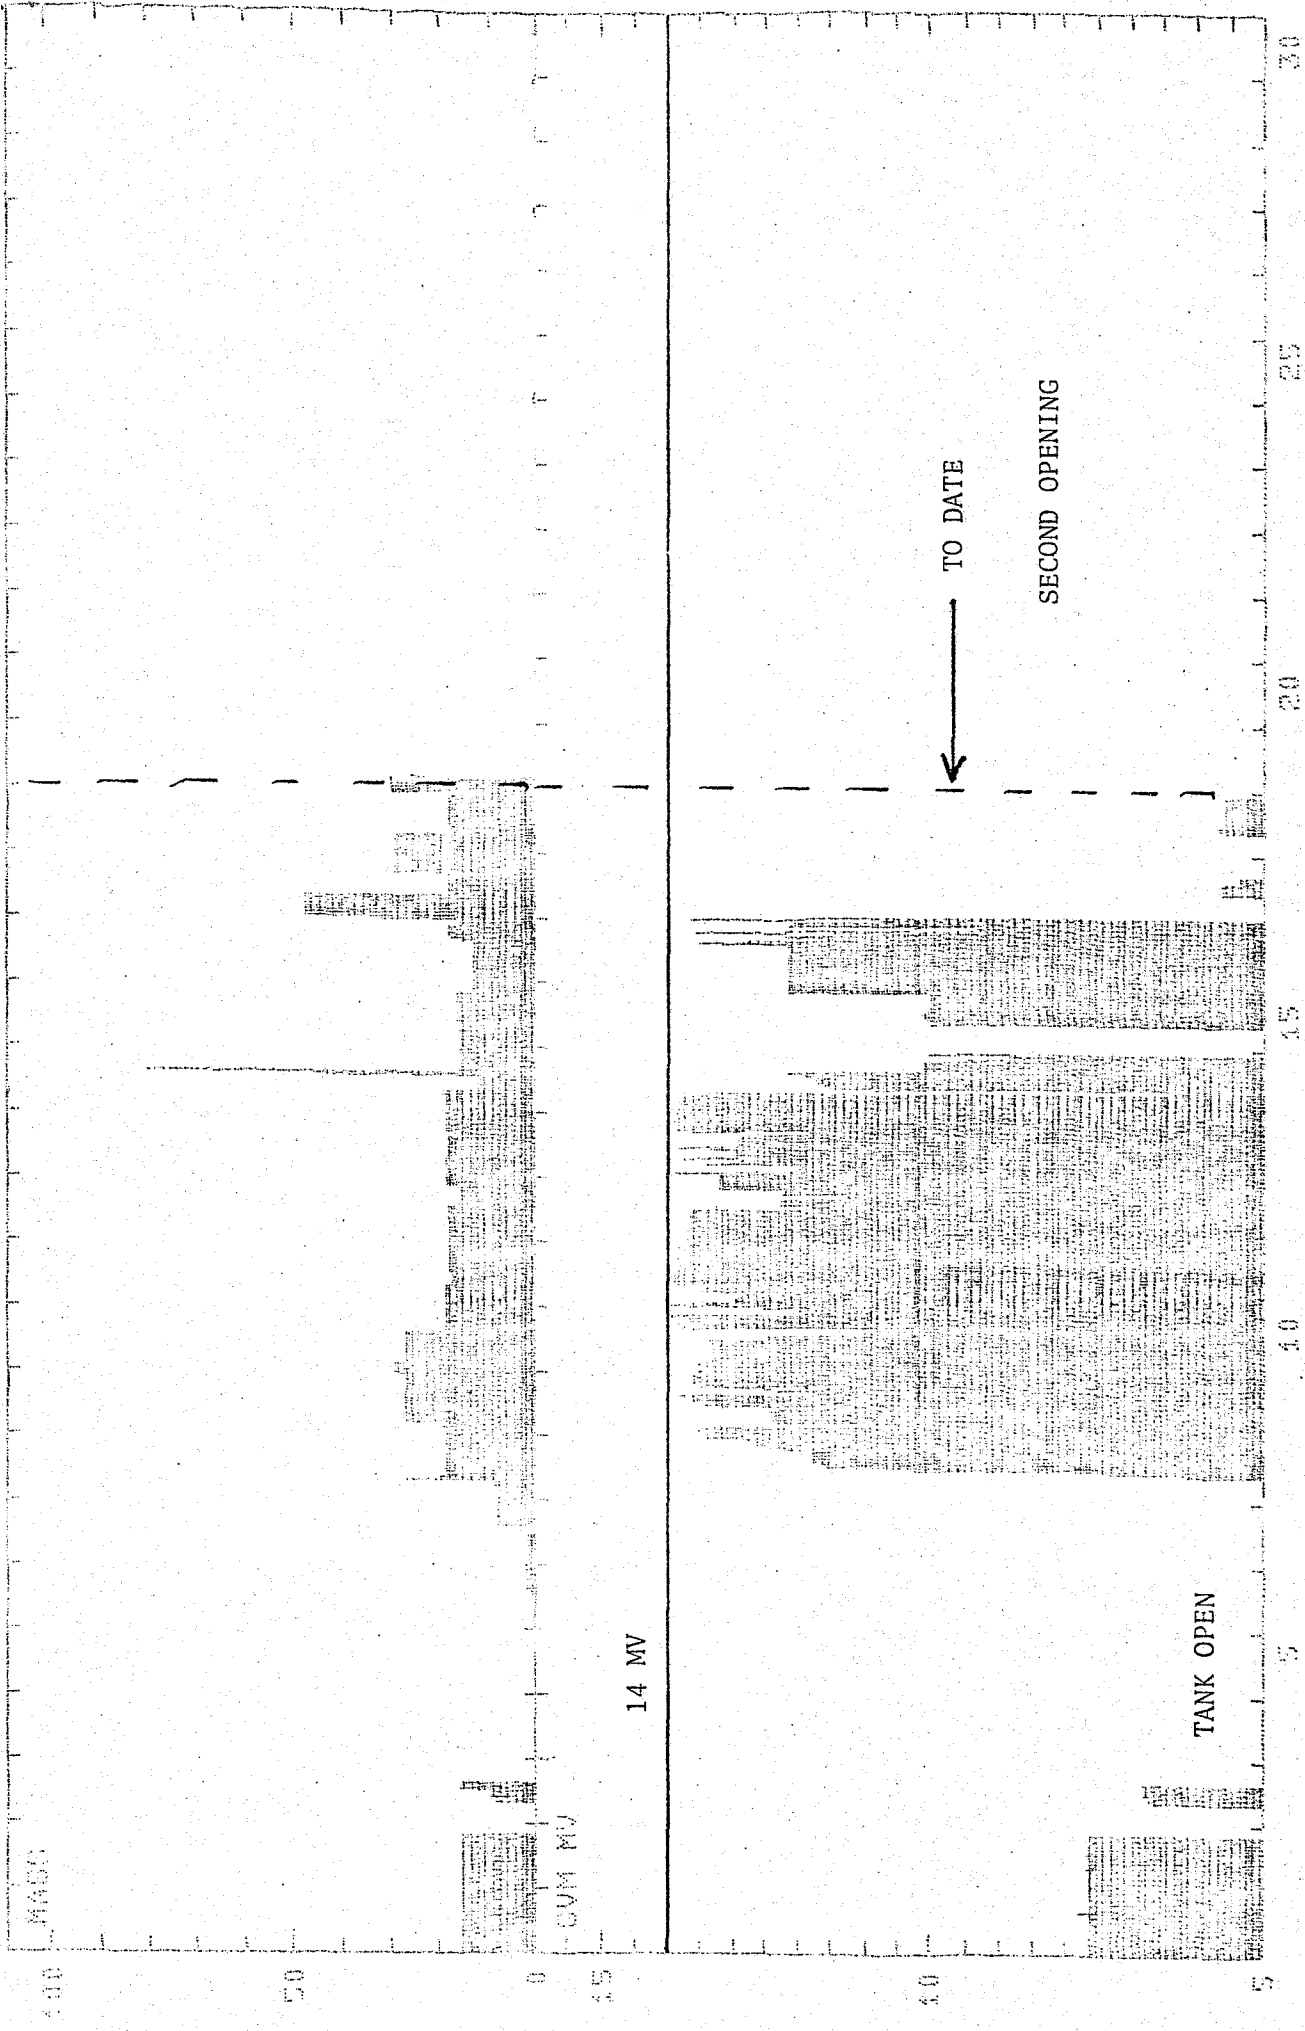
14UD 3.07 APRIL 1983

NOTE: On the plot of terminal voltages we have drawn a horizontal line at 14 MV for easy reference to performance near the nominal voltage limit of the 14UD.
