AUSTRALIAN NATIONAL UNIVERSITY

DEPARTMENT OF NUCLEAR PHYSICS

14UD TANK OPENING REPORT No.44

27th to 29th March 1984

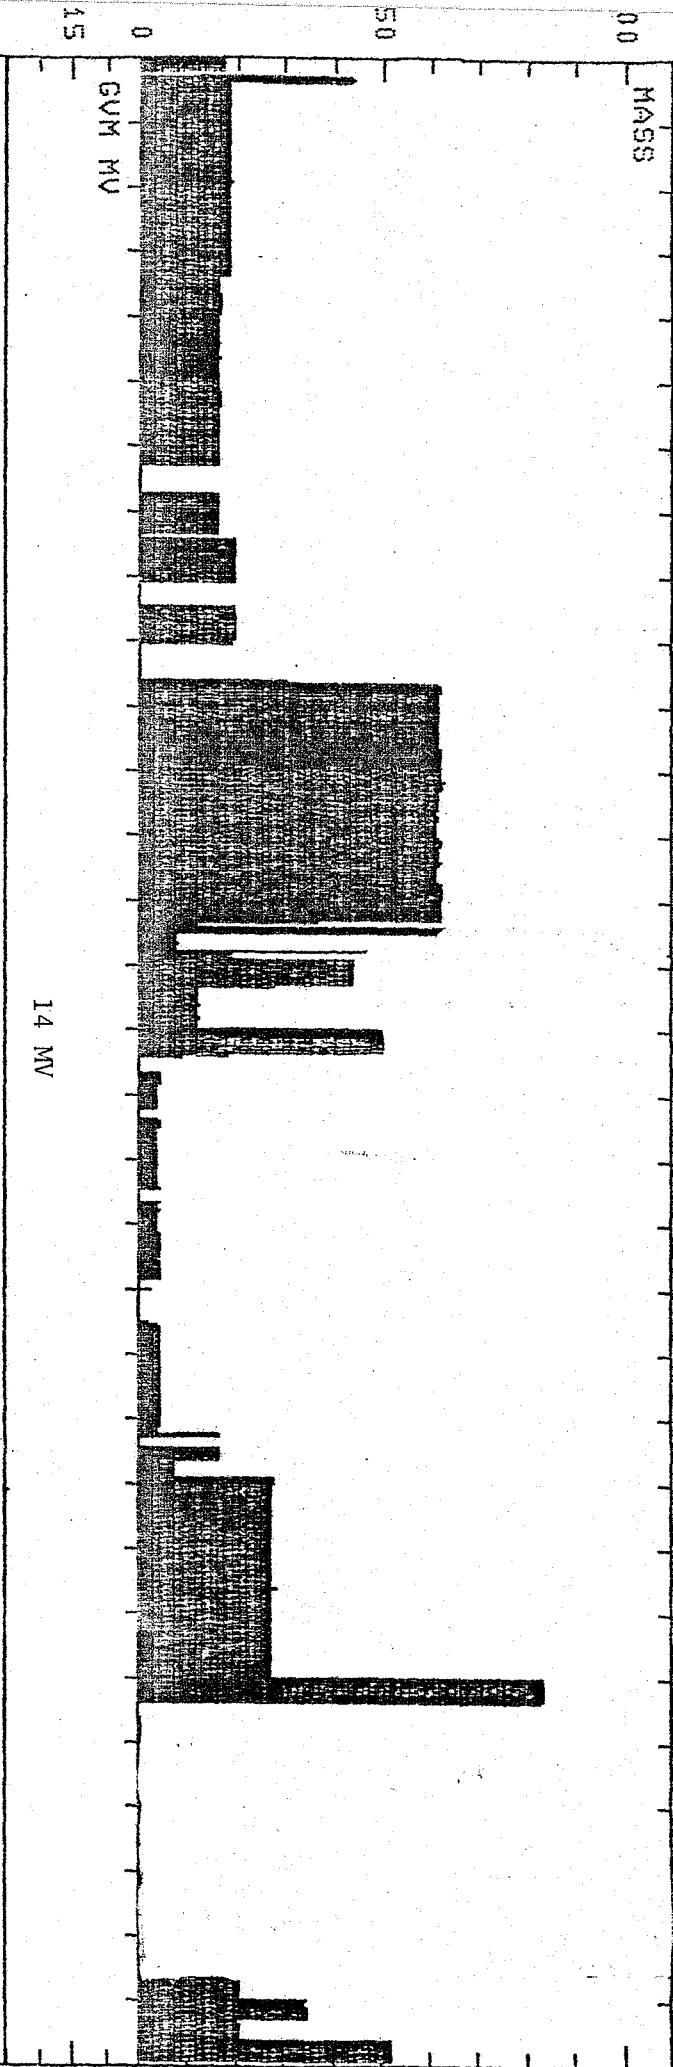
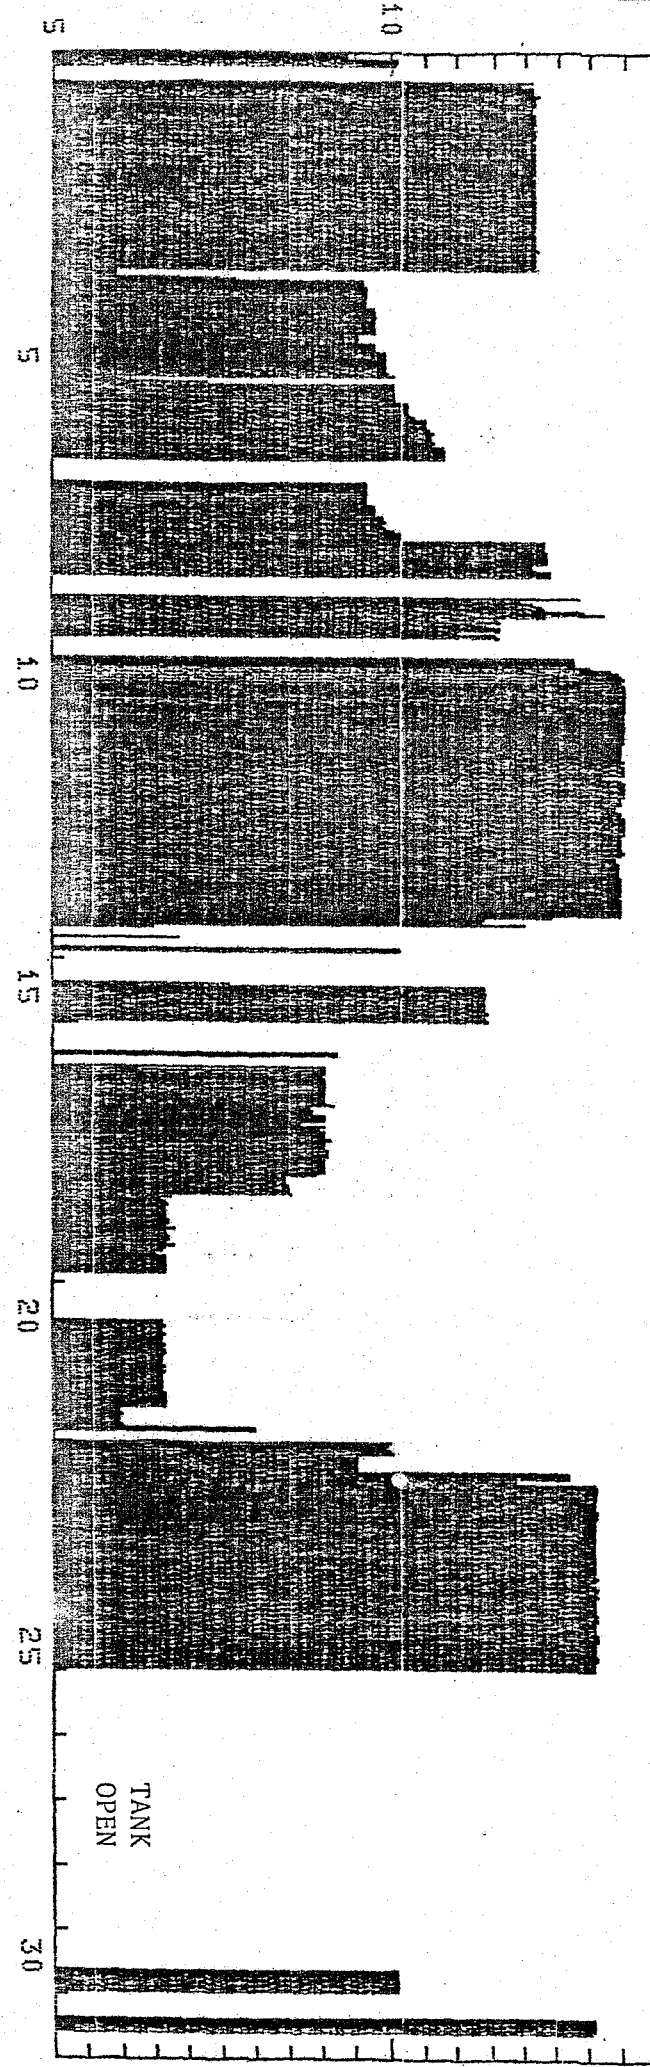
1000 JD 1000 MARCH 1984

NOTE: On the plot of terminal voltages we have drawn a horizontal line at 14 MV for easy reference to performance near the nominal voltage limit of the 14UD.
